Technical Article

Microstructural Investigations and Fracture Analysis of a Multi-Layer Al Panel of a Crashed Aircraft

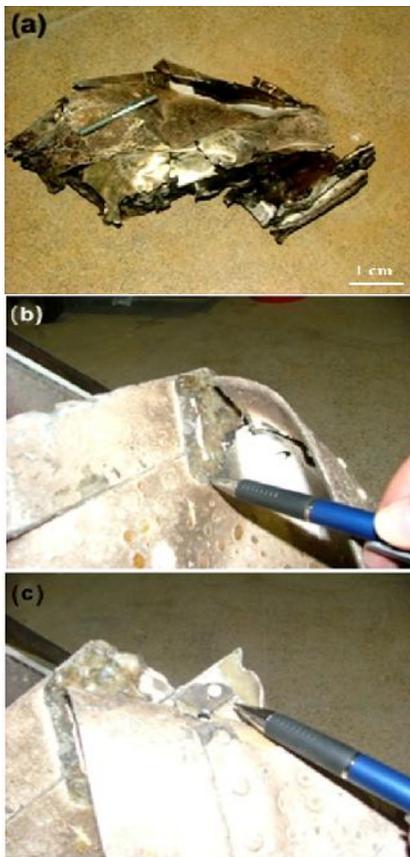
Fig. 1. shows visual inspection of received sample. Pictures depict that the part was completely deformed due to the crashing and excessive heat induced from the crash site or even during the service. It may have assisted cracking associated with rivets, (Figs. 1(b) and (c)).

Fig. 1. Visual inspection of (a) received sample, (b) and (c) magnified views of (a).

Riveting on received sample was selected for further microstructural investigations because visual inspections, as in Fig. 1(c), showed that they might have been responsible for cracking.

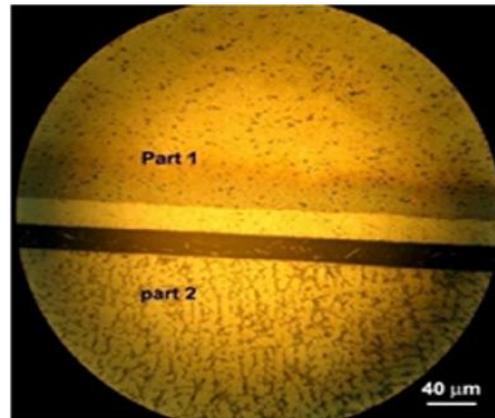
Fig. 3. presents optical microscopy of prepared sample, revealing an insulating polymeric layer, visible as a dark layer, separates the outer section of trunk, denoted as part 1, from the interior, denoted as part 2. It is clear that each part is characterized by different microstructural features which should be separately analyzed.

Fig. 3. Image of the sample showed in, Figure 2, optical microscopy of different layers.

The clad surface is resistant to corrosive attack and also provides additional cathodic protection to Al 2024 layer [19]. As observed in Fig. 3., a part of layer L1, adjacent to L2, has been heat-colored due to cladding process. Although, the clad layer increases corrosion resistance of Al 2024 but different thermal and mechanical properties for L1 and L2 potentially increases the risk of premature fracture due to thermo-mechanical fatigue. This should be taken more seriously into consideration for areas near the engines, where excessive heating and cooling cycles are engaged.

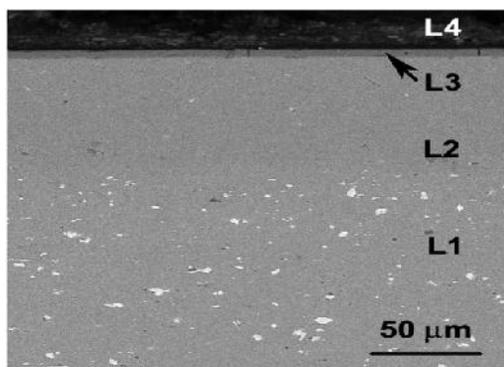
Fig. 4. shows the SEM micrograph of part 1, seen on Fig. 3. Micrograph depicts that the sample seems to be composed only in 4 layers, denoted as L1 to L4, from outer surface of the airplane trunk inward. Layer indicated by L4 is the polymeric insulating layer between outer (part 1) and inner (part 2) of the airplane trunk. This layer is crucial to avoid sound and heat get in or out of the airplane cabin. In order to characterize the underneath layers (L1, L2 and L3), individual EDS analyses were carried out.

Fig. 4. SEM micrograph of part1, representing four different layers.

In the SEM micrographs of Figs. 4. and Fig. 6., a distribution of second phase particles within the size range of 1 to 8 micron can be observed in L1.

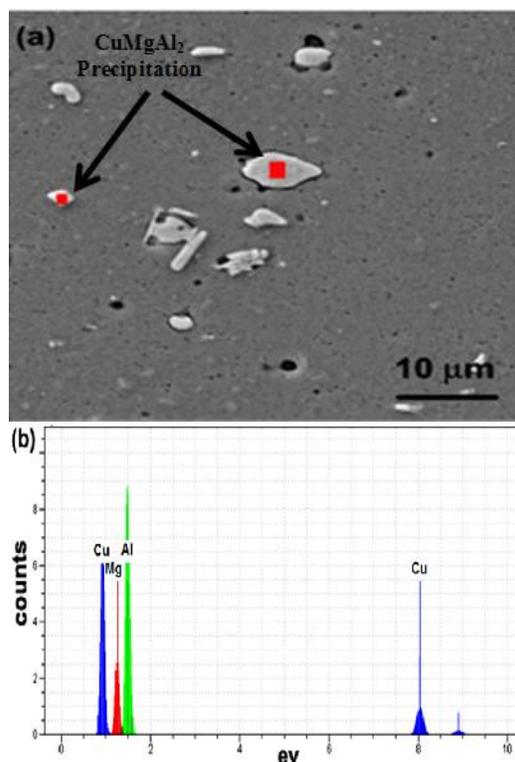
Fig. 6. shows a magnified SEM micrograph of layer L1 and EDS analysis of second phase particles. According to the results, the precipitated phase is composed of about 55.8 wt. % Cu, 33.6 wt. % Al and 10.5 wt. % Mg complying with a non-stoichiometric compound, the CuMgAl_2 . These precipitates are usually formed in Al 2024 aging heat treatment process as a major source of alloy strengthening [16, 17].

It seems that some particles have grown in service, presumably due to exposing to high temperatures of the engines. As mentioned before, coarsening of second phase particles will decrease the strength as well as fracture toughness of the alloy.

The coarsen particles particularly increase the stress concentration factors and might lead to a premature cracking.

Fig. 6. (a) Magnified SEM micrograph of layer L1 seen on Fig. 3., (b) EDS analysis of selected particles in (a).

Over-aging occurs not only in a prolonged aging treatment, but it also can develop during service at high temperatures. This phenomenon is undesirable and the weakened alloy should be rejuvenated by a new cycle of solution treatment and aging. Furthermore, due to the presence of Si, Fe, and Mn in Al 2024, formation of other detrimental phases such as Mg_2Si , $\text{Cu}_2\text{Mg}_8\text{Si}_5\text{Al}_4$, and $(\text{Cu, Fe, Mn})\text{Al}_6$ would also be expected during prolonged aging or exposure to high temperatures at service.

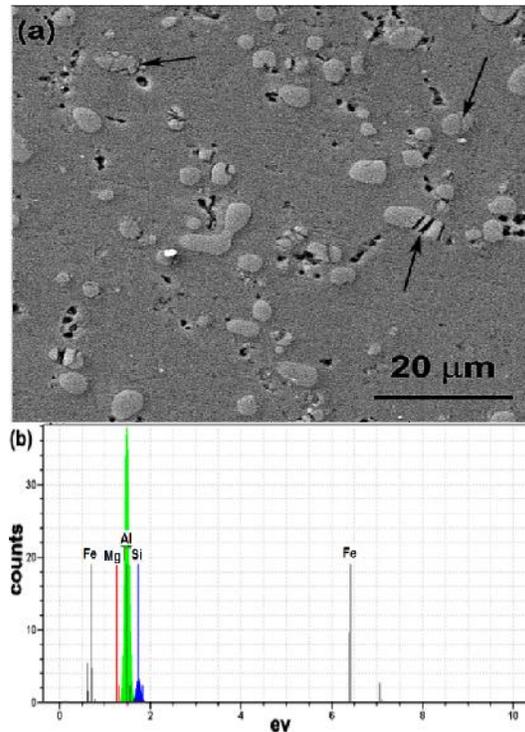
Microstructural image and the EDS analysis of part 2, seen on Fig. 3., are shown in Fig. 9. EDS analysis showed that this layer is mostly composed of about 86.5 wt. % of Al, 13 wt. % of Si, Fe and Mg as the remainder. The analysis actually complies with Al-Si casting alloys (especially alloy 413) consisted of a matrix rich in Al and shapeless Si islands [20]. It is known well that the silicon particles in such alloys tend to form globular when aged or subjected to heat

in service. This would be other symptom for sections of trunk near the airplane engines. It is also worthy to mention that some micro-cracks are visible within Si particles. Pointed particles on Fig. 9. (a) show that, cleavage micro-cracks may have formed before or even during the crash. It is clear that if the material was subjected to high temperatures for long time, silicon particles tended to agglomerate and form larger spherical ones. This in turn increases the tendency for cleavage cracking which may have propagated through particles..

Fig. 9. (a) Magnified SEM image, and (b) EDS analysis of Part2, seen on Fig. 3.

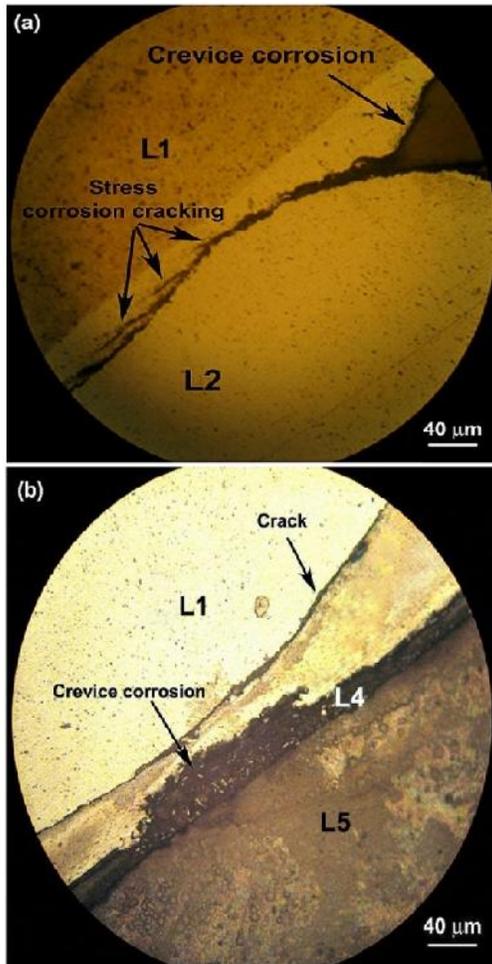
Failure analysis on the airplane body part was focused on the fracturing because of possible corrosion and the fatigue because of working conditions. Part actually was subjected to overheating which may have caused coarsening in Cu-Mg particles in Al 2024 alloy (layer L1) and the Si particles in alloy 413 (layer L5). In addition, cyclic heating and cooling of part increased risk of thermo-mechanical fatigue. It is worthy to mention that corrosion played detrimental roles, particularly when stresses are intensified in areas adjacent to rivets [8]. Fig. 10. shows cracking emerged in layers L2 and L3 close to a rivet.

Fig. 10 (a). shows that a crack has initiated from a crevice corrosion position under a rivet and the stress concentration field around it caused its propagation into layer L2. In Fig. 10 (b)., crevice corrosion is

observed in interlayer region between L2 and L4. Corrosion is ruining the protective anodize layer (L3) and advancing into layer L2. This is potentially a weak position for cracking as shown in Fig. 10 (a). Existing stress concentration fields around the rivets making the condition more severe in regards with crack initiation and propagation, as in Fig. 10 (a).

Fig. 10. (a,b) Optical microscopic imaging of cracks and crevice corrosion at two positions behind a rivet.

Fig. 10 (b). shows that at some positions cracks may adopt a way into layer L1 instead. These positions are where the material is subjected to engines heating and the precipitates in layer L1 tended to become coarser [21]. Coarsening is usually accompanied by changing interface with matrix into incoherent state making the material locally susceptible to cracking. At such condition, not only the strength decreases, but the fracture toughness degrades as well. In a material with coarsened particles, the interphase interfaces will be prone to incoherency and cracking. This is demonstrated clearly in Fig. 11.

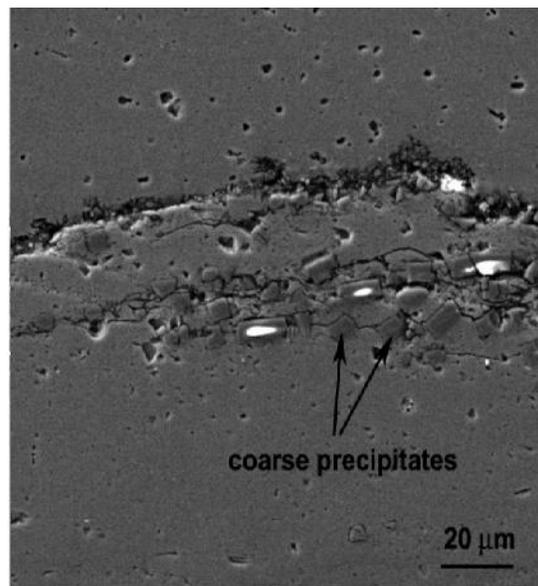
Showing a magnified SEM image of a crack propagated in layer L1.

Fig. 11. SEM micrograph of crack propagation in layer L3 in favor of coarse precipitates formed during heating.

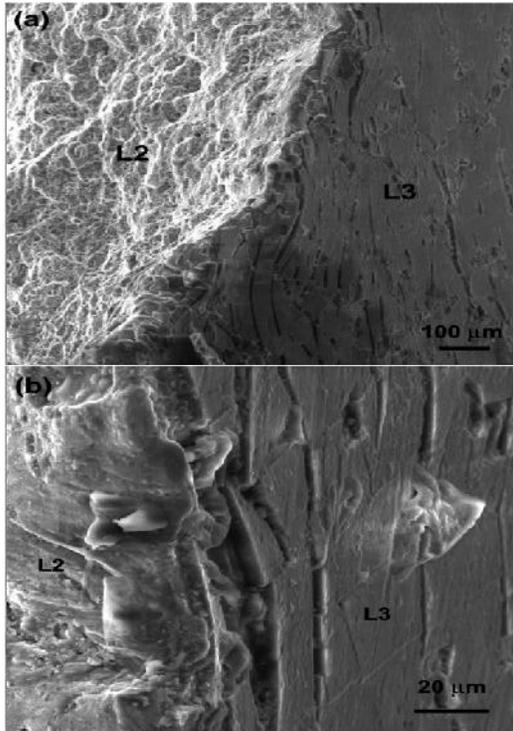
Fig. 12. shows two SEM micrographs of fracture surface between layers L2 and L3 in different magnifications. Faceted fracture surface within L3 is a sign of its brittleness, unlike the L2 which can be characterized by a fibrous ductile fracture appearance.

Different fracture features for these layers could have been related directly to their chemical compositions and microstructures. Micro-cracks appeared in L3 adjacent to the interfaces may be caused by thermo-mechanical fatigue due to different thermal properties of the layers. The fracture surface in layer L1 is represented in Fig. 13. Fibrous appearance of the failed surface with small dimples implies that the material has undergone plastic deformation before fracture.

Fig. 12. (a,b) SEM micrograph of a failed cross section between layer L2 and L3.

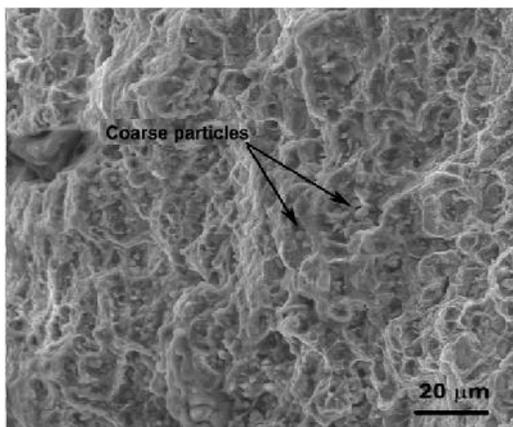
It is also worthy to mention that some of these dimples, most possibly those pointed by arrows contains large second-phase particles.

This fortifies the previous observations, as in Fig. 13.,

and highlights the contributions of coarsened particles on the micro cracks initiations final fracturing.

Fig. 13. SEM micrograph of a fracture surface within layer L1.
