Technical Article

Microstructural Investigations and Fracture Analysis of a Multi-Layer Al Panel of a Crashed Aircraft

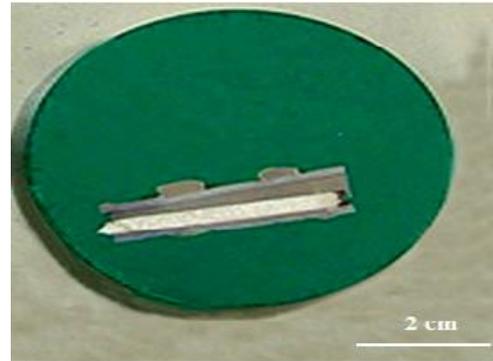
Riveting on received sample was selected for further microstructural investigations because visual inspections, as in Fig. 1(c), showed that they might have been responsible for cracking.

Fig. 2. Selected section of received sample mounted for metallographic preparation.

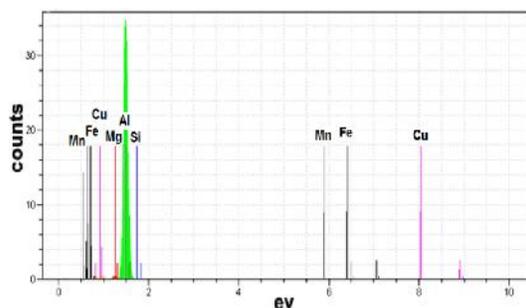
Fig. 5. EDS results of layer L1, seen on Fig. 4.

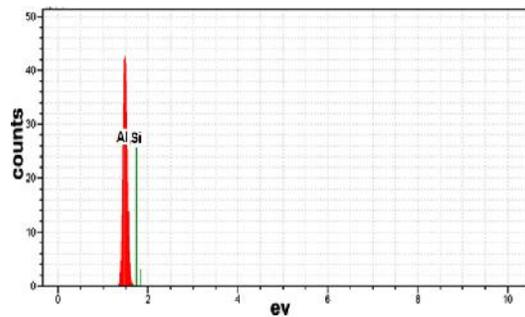
EDS analysis of the second layer (L2), shown in Fig. 7., indicates that this layer is mostly composed of Al (99.6 wt. %) with about 0.4 wt. % of Si. Therefore, this inferred that L2 is a clad layer of nearly pure Al on L1.

Fig. 7. EDS analysis of layer L2, seen on Fig. 4.

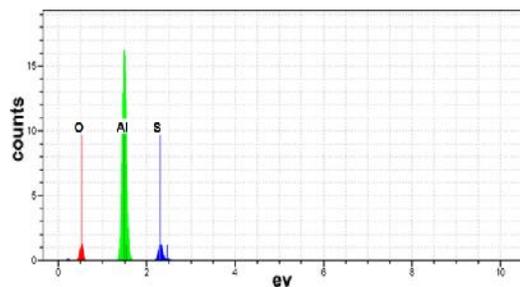
EDS analysis of L3 in Fig. 8. indicates that, this is an anodized layer performing as top metallic layer (below the insulation) to protect underneath layers from possible corrosive environments from inside. Analysis result depicted that anodize layer is mainly consisted of 67.7 wt. % Al, 25.5 wt. % O₂ and about 7 wt. % of S.

Fig. 8. EDS analysis of the layer L3 seen on Fig. 4.
